**FACILITIES ASSESSMENT
FOR THE
GORHAM RANDOLPH SHELBURNE
COOPERATIVE SCHOOL DISTRICT**

**ED FENN SCHOOL
MIDDLE SCHOOL/HIGH SCHOOL
GORHAM, NH**

JUNE 22, 2006

ED FENN SCHOOL FACILITIES REPORT JUNE 22, 2006

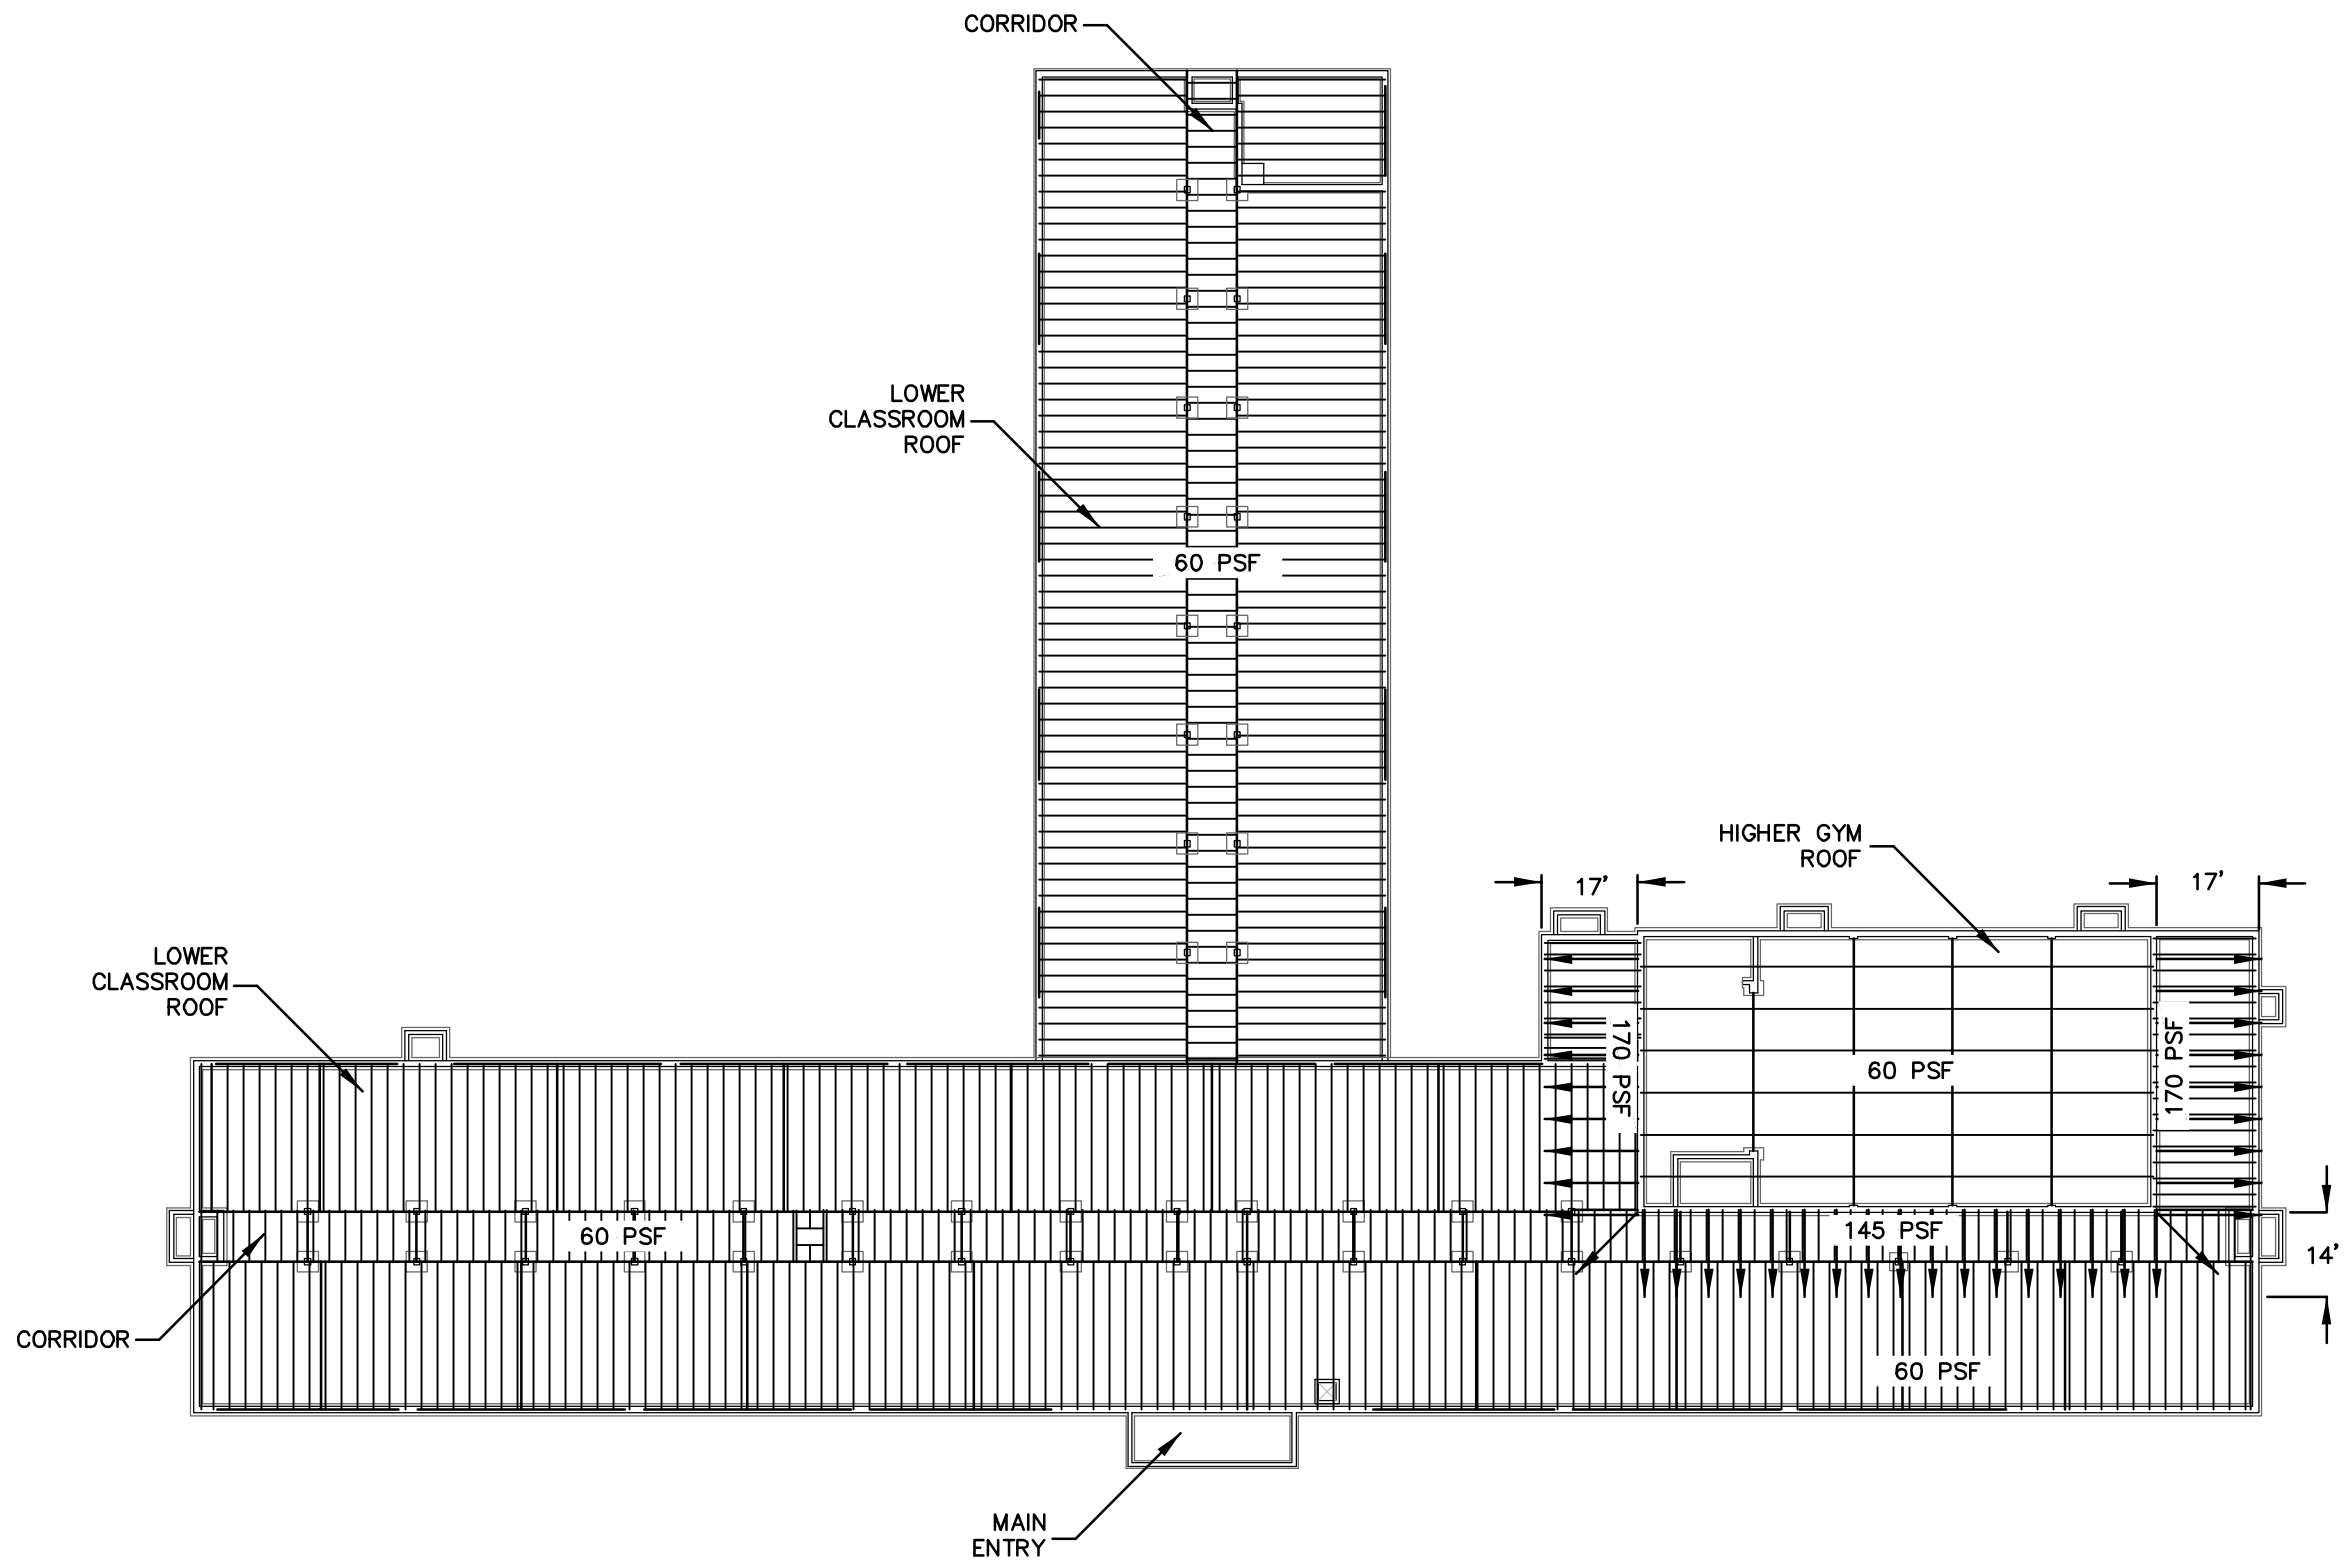
- Flat Roof Snow Load: **$P_f = 60$ psf**
Drift (west & east of gym): **$P_d = 105$ psf ($w = 17'$)**
Drift (north of gym): **$P_d = 85$ psf ($w = 14'$)**

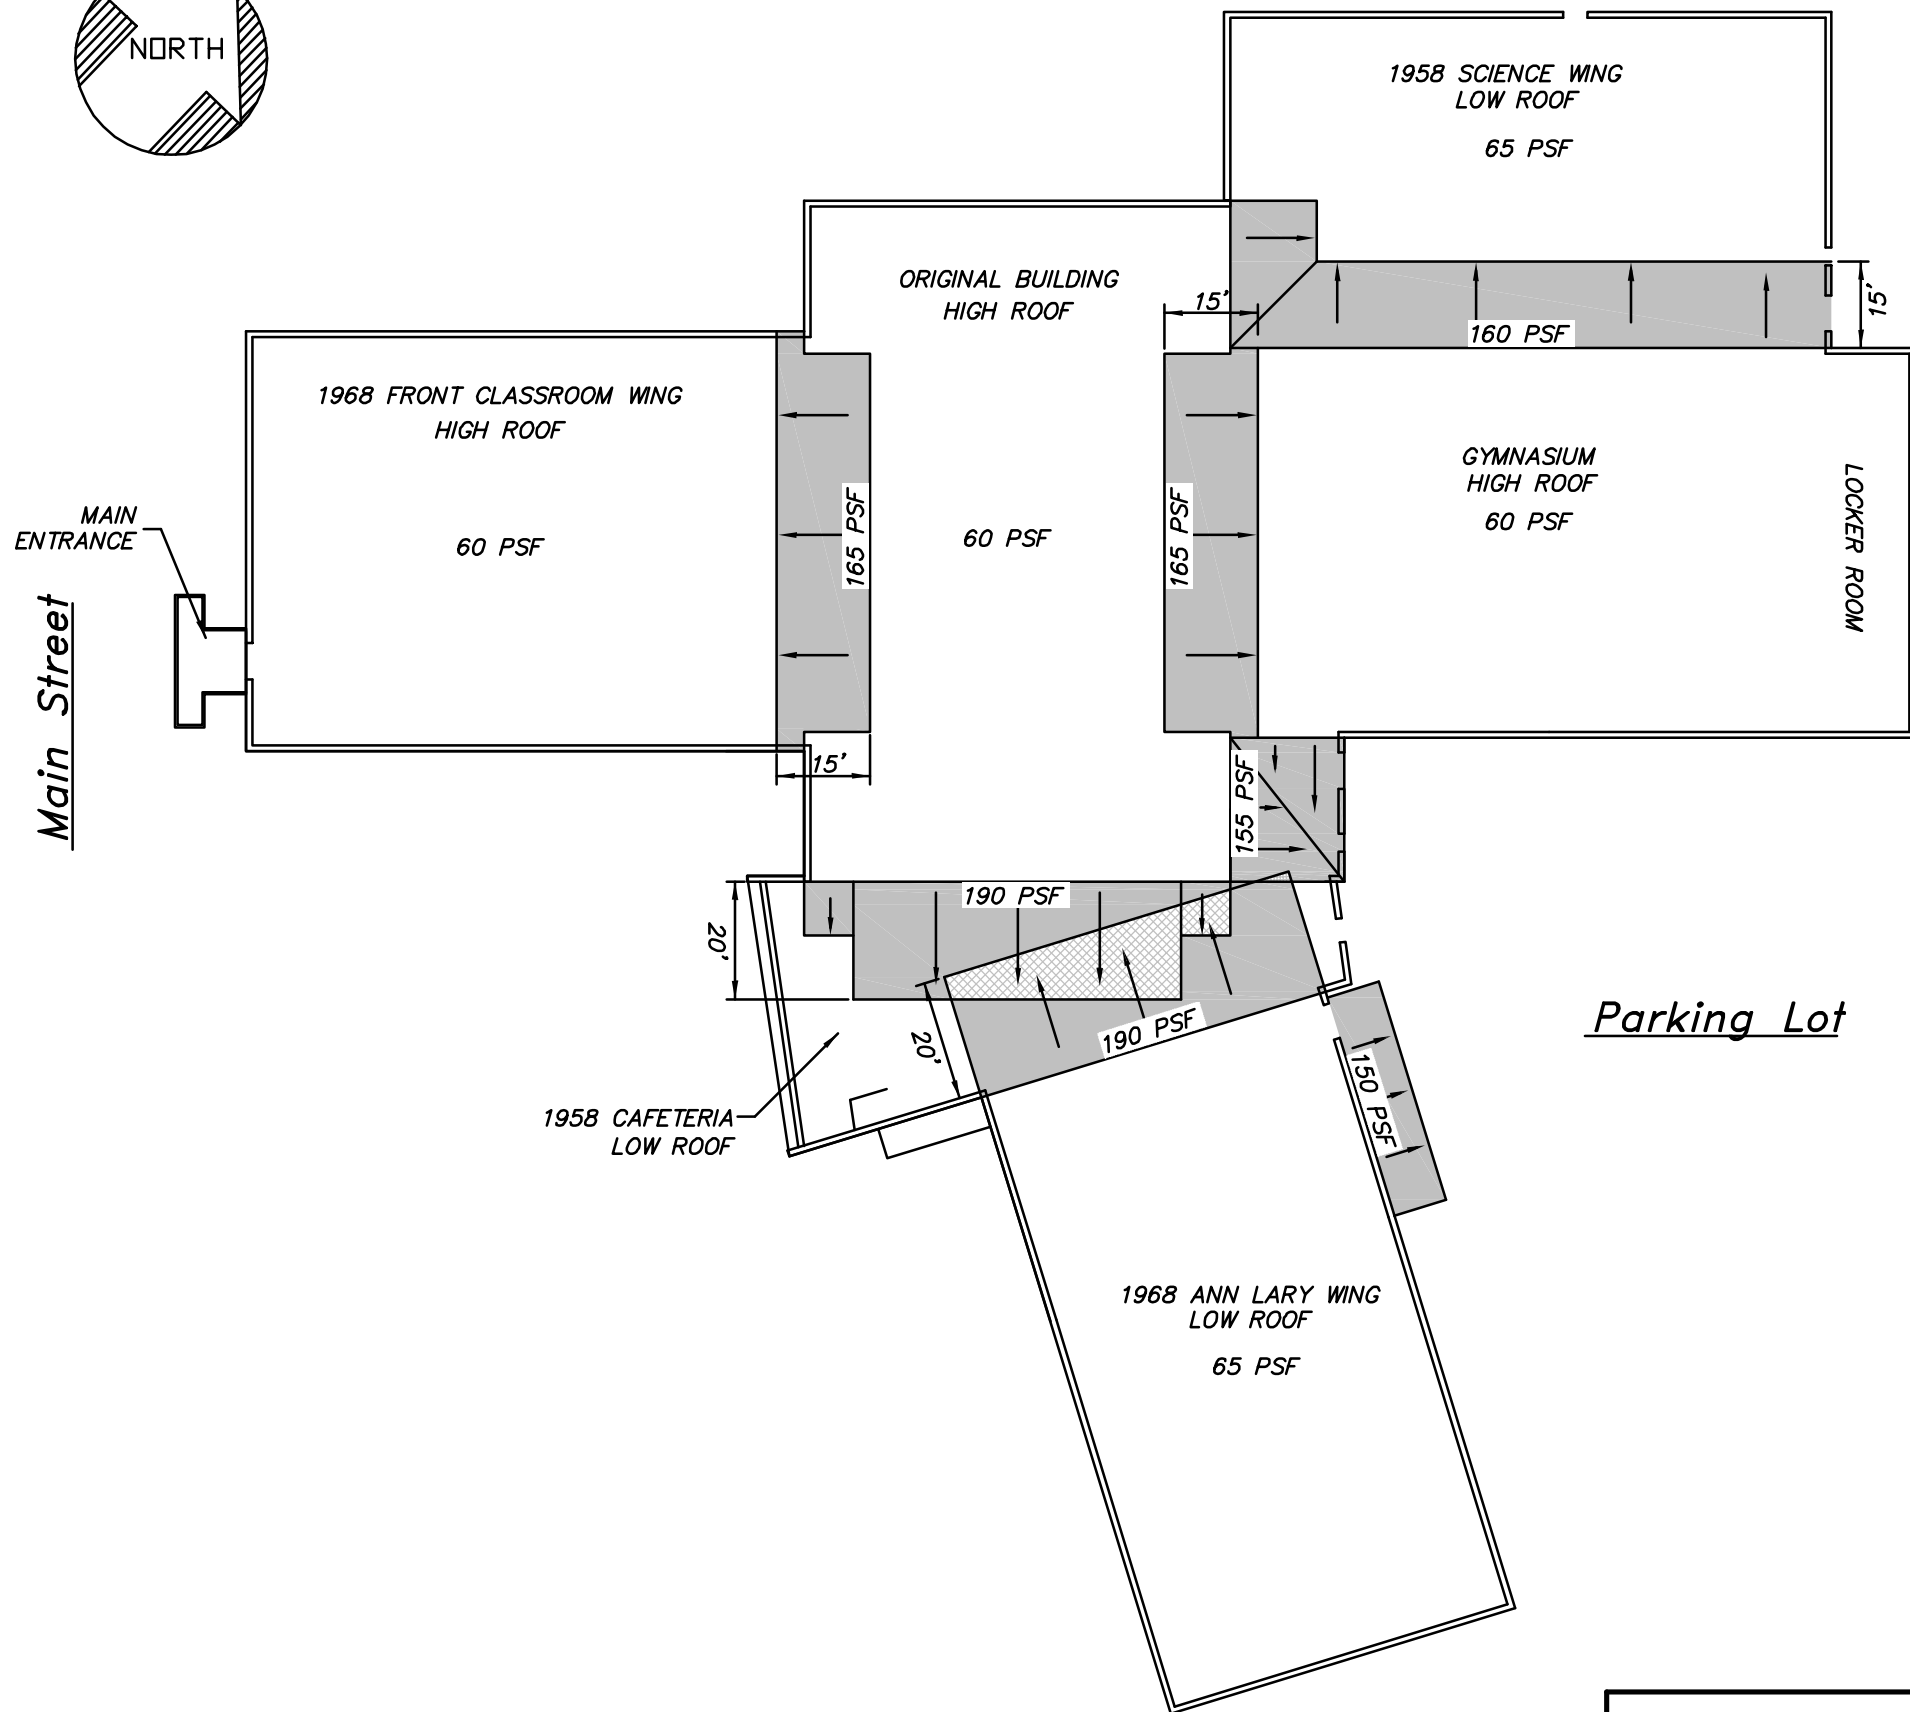
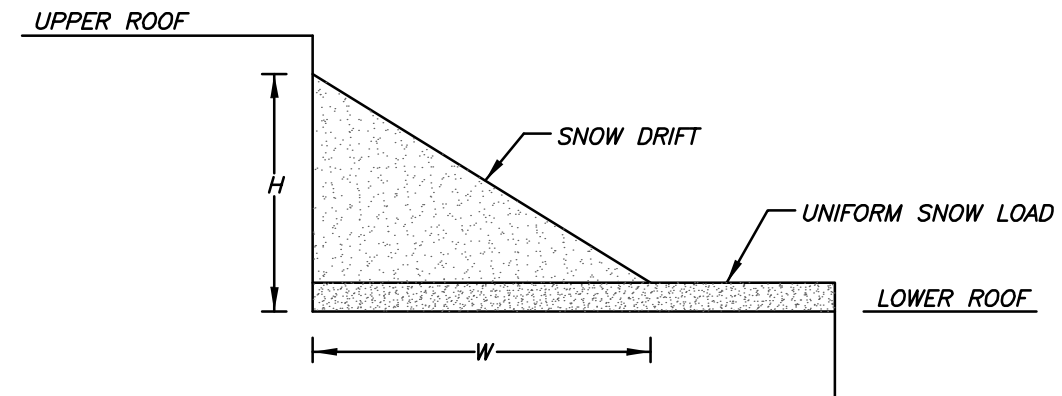
SNOW DRIFT DIAGRAM

Flat Roof Snow Loads: **$P_f = 60$ psf (high roofs)**
 $P_f = 65$ psf (low roofs)
Drift Loads: **$P_d = \text{varies from } 100 - 130$ psf**
 See the attached Snow Load Diagram
