**FACILITIES ASSESSMENT
FOR THE
GORHAM RANDOLPH SHELBURNE
COOPERATIVE SCHOOL DISTRICT**

**ED FENN SCHOOL
MIDDLE SCHOOL/HIGH SCHOOL
GORHAM, NH**

JUNE 22, 2006

ED FENN SCHOOL FACILITIES REPORT JUNE 22, 2006

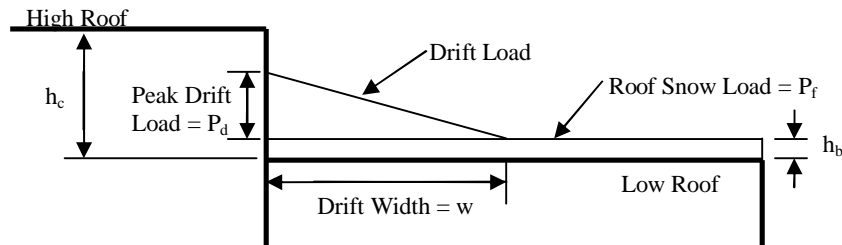
The building, as constructed, has two different height flat roofs. For this reason, the following snow load sections of ASCE 7-98 also apply: (section 7.3) Flat Roof Snow Loads and (section 7.7) Drifts on Lower Roofs. For the drift loads both windward and

leeward directions were considered and worst-case applied to the balanced snow loads.

The following snow loads and drift loads for the roofs were calculated using the above-mentioned codes:

- Flat Roof Snow Load: **$P_f = 60$ psf**
Drift (west & east of gym): **$P_d = 105$ psf ($w = 17'$)**
Drift (north of gym): **$P_d = 85$ psf ($w = 14'$)**

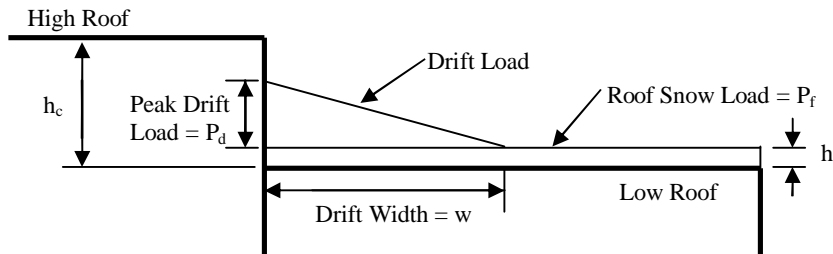
The building, as constructed, has several different height flat roofs. For this reason, the following snow load sections of ASCE 7-98 also apply: (section 7.3) Flat Roof Snow Loads and (section 7.7) Drifts on Lower Roofs. For the drift loads both windward and leeward directions were considered and worst-case applied to the balanced snow loads.

The following snow loads and drift loads for the roofs were calculated using the above-mentioned codes:

Flat Roof Snow Loads: **$P_f = 60$ psf (high roofs)**
 $P_f = 65$ psf (low roofs)
Drift Loads: **$P_d = \text{varies from } 100 - 130$ psf**
 See the attached Snow Load Diagram
